# HOME BUILDING TECHNOLOGY SERVICES, LLC

Report #2017-04

Subject: Bath fan closed door operating conditions

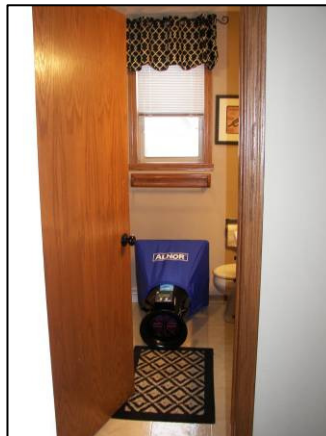
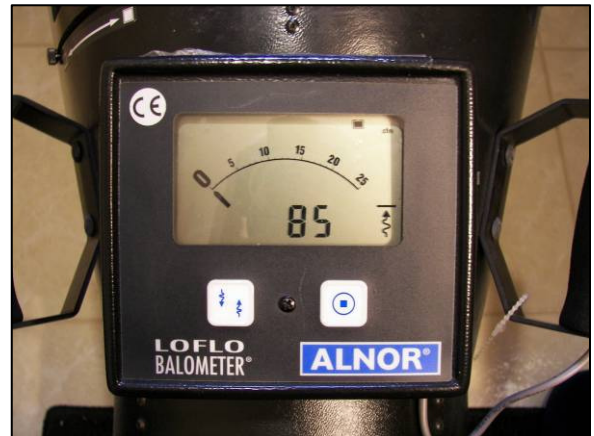
**Step 1** door position: **open**

**Bathroom #1**

- Area: 62.6 sq/ft
- Volume: 500.80 <sup>3</sup>/ft
- One wall plus the ceiling exposed to the outside
- Fan rated at 110
- Tested at 85 cfm
- 77% of rated flow

**Room Conditions:** Bathroom door wide open, window closed and no intentional restrictions

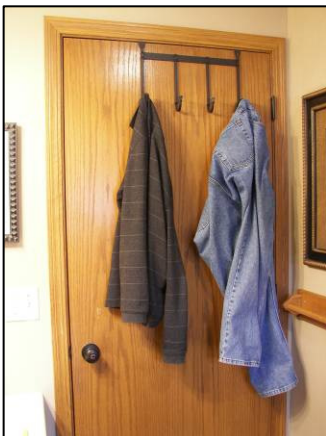
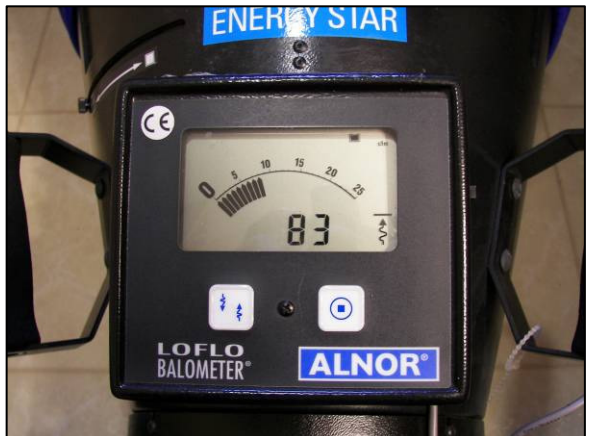
**Step 2** door position: **closed**

- Tested at 83 cfm
- 75% of rated flow
- 85-83= 2 cfm lower
- 2% flow reduction
- Room pressure: -2.1

**Room Conditions:** Bathroom door closed tight, window closed and no intentional restrictions. Room does have one forced air floor diffuser and the door undercut for fan replacement air when the fan is running. The forced air supply and door undercut are not sealed.

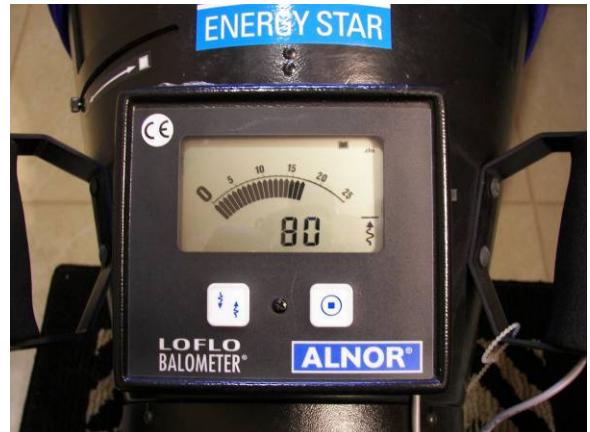
**Step 3** door position: **closed**

- Tested at 80 cfm
- 73% of rated flow
- 83-80= 3 cfm lower
- 3.5% flow reduction
- Room pressure: -4.2

**Room Conditions:** Bathroom door closed tight, window closed, **forced air supply now sealed off** but the door undercut is still open.

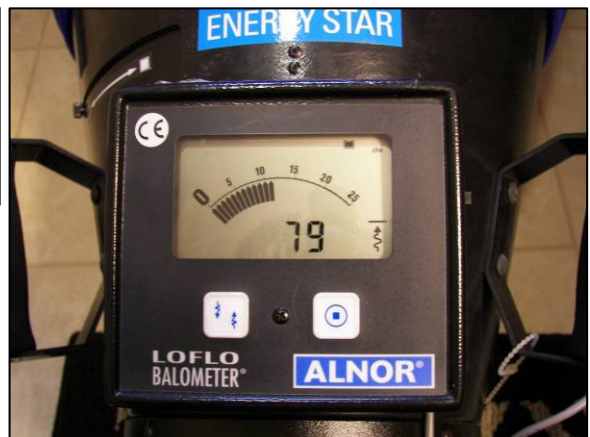
**Step 4** door position: **closed**

- Tested at 79 cfm
- 72% of rated flow
- 80-79= 1 cfm lower
- 1.3% flow reduction
- Room pressure: -11.5

**Room Conditions:** Bathroom door closed tight, window closed, **forced air supply still sealed off** but now the **door undercut is also sealed off**.

The fan is still doing 79 cfm and this is with all obvious visual paths of replacement air very well sealed off! Because 3 of the 4 walls for this bathroom are adjacent to other interior conditioned space, the replacement air is coming from these areas.

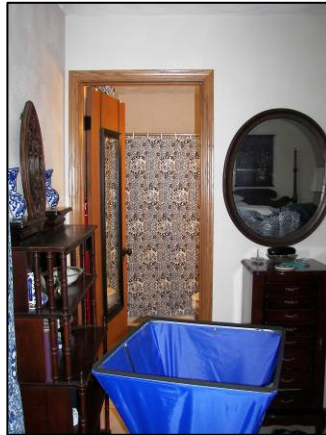
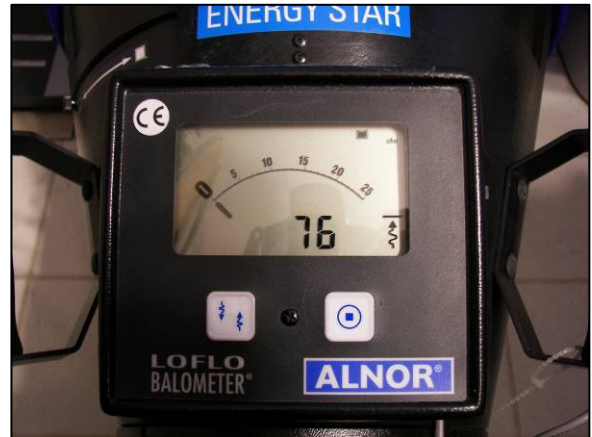
**Step 1** door position: **open**

- Area: 42.2 sq/ft
- Volume: 337.60 <sup>3</sup>/ft
- Two walls plus the ceiling exposed to the outside
- Fan rated at 80
- Tested at 76 cfm
- 95% of rated flow

**Room Conditions:** Bathroom door wide open, window closed and no intentional restrictions

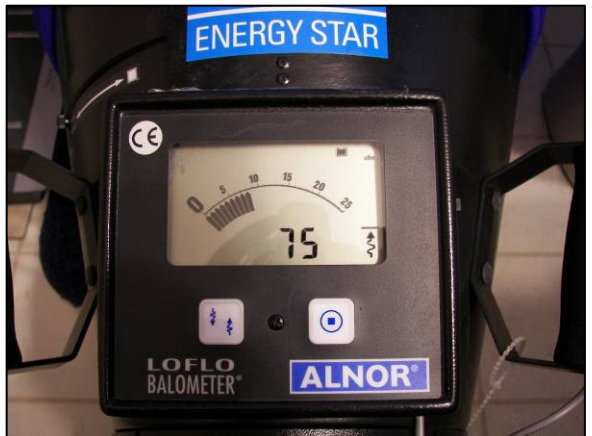
**Step 2** door position: **closed**

- Tested at 75 cfm
- 94% of rated flow
- 76-75= 1 cfm lower
- 1% flow reduction
- Room pressure: -1.8

**Room Conditions:** Bathroom door closed tight, window closed and no intentional restrictions. Room does have one forced air floor diffuser and the door undercut for fan replacement air when the fan is running. Forced air supply and door undercut are not sealed.

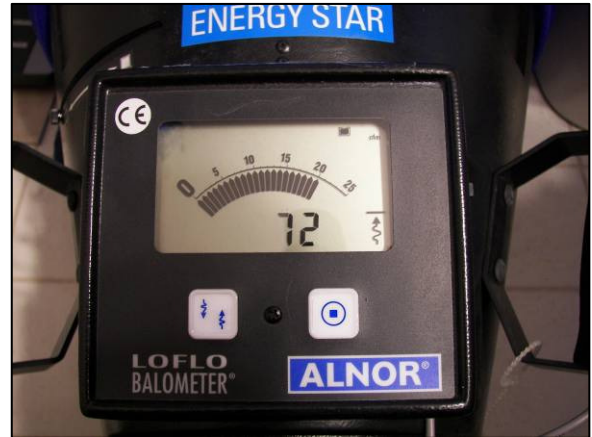
### Step 3 door position: **closed**

- Tested at 72 cfm
- 90% of rated flow
- 75-72= 3 cfm lower
- 4% flow reduction
- Room pressure: -3.1

**Room Conditions:** Bathroom door closed tight, window closed, **forced air supply now sealed off** but the door undercut is still open.

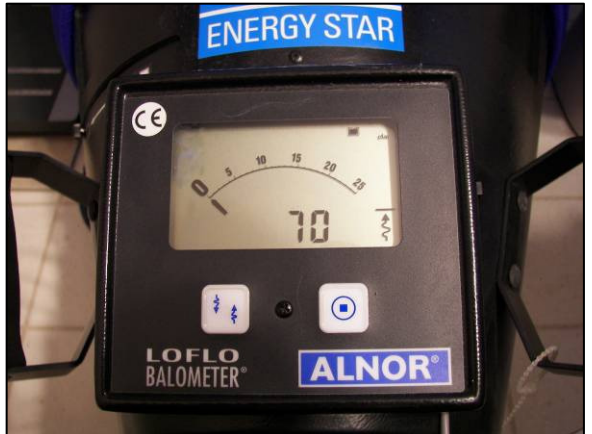
### Step 4 door position: **closed**

- Tested at 70 cfm
- 86% of rated flow
- 72-70= 1 cfm lower
- 1.3% flow reduction
- Room pressure: -6.6

**Room Conditions:** Bathroom door closed tight, window closed, **forced air supply still sealed off** but now with **door undercut also sealed off**.

The fan is still doing 70 cfm and this is with all obvious visual paths of replacement air very well sealed off! Because 2 of the 4 walls for this bathroom are adjacent to other interior conditioned space, the replacement air is coming from these areas.
